FLOODING IN BOURNEMOUTH
23rd June 2016
Section 19 Report (Floods and Water Management Act 2010)
for
Flooding Advisory Group

Final 16/12/2016

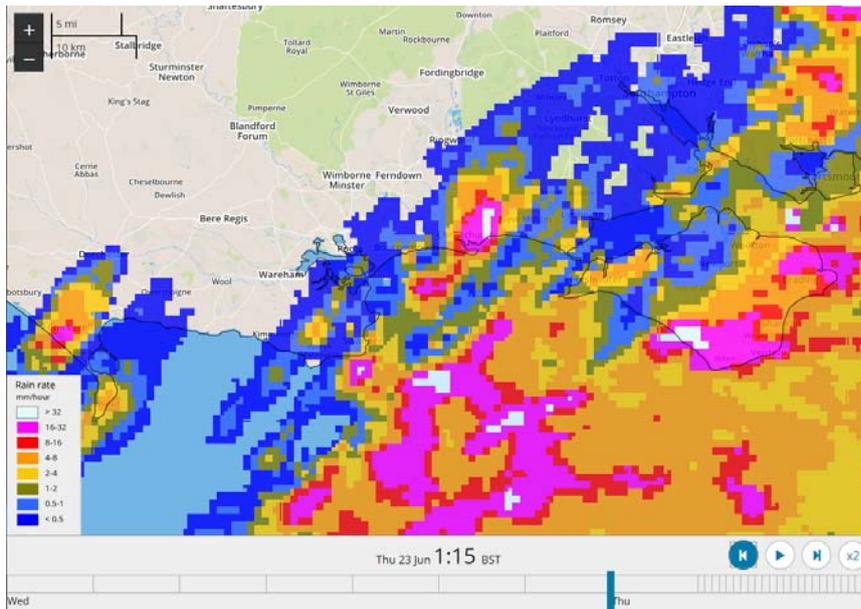
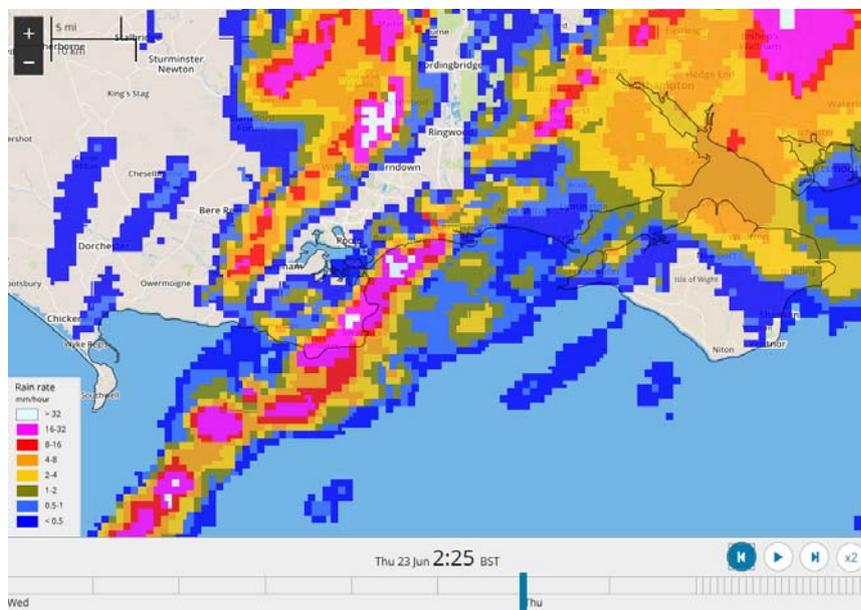
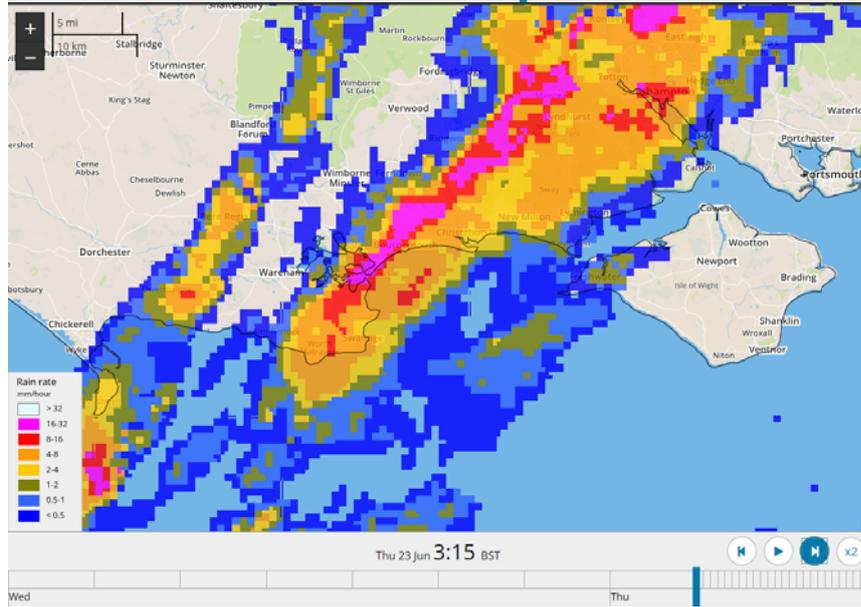
3.3 The following shows “snap shots of the actual rainfall radar which shows that the vast bulk of the rainfall was mainly out to sea but just for a while “drifted” in land. The rain gauges suggest that the heaviest rainfall was actually in Southbourne and the Strouden areas of Bournemouth (confirmed by the Wessex Water rain gauge at Berry Hill). THERE WAS NO REPORTED FLOODING IN THESE AREAS.

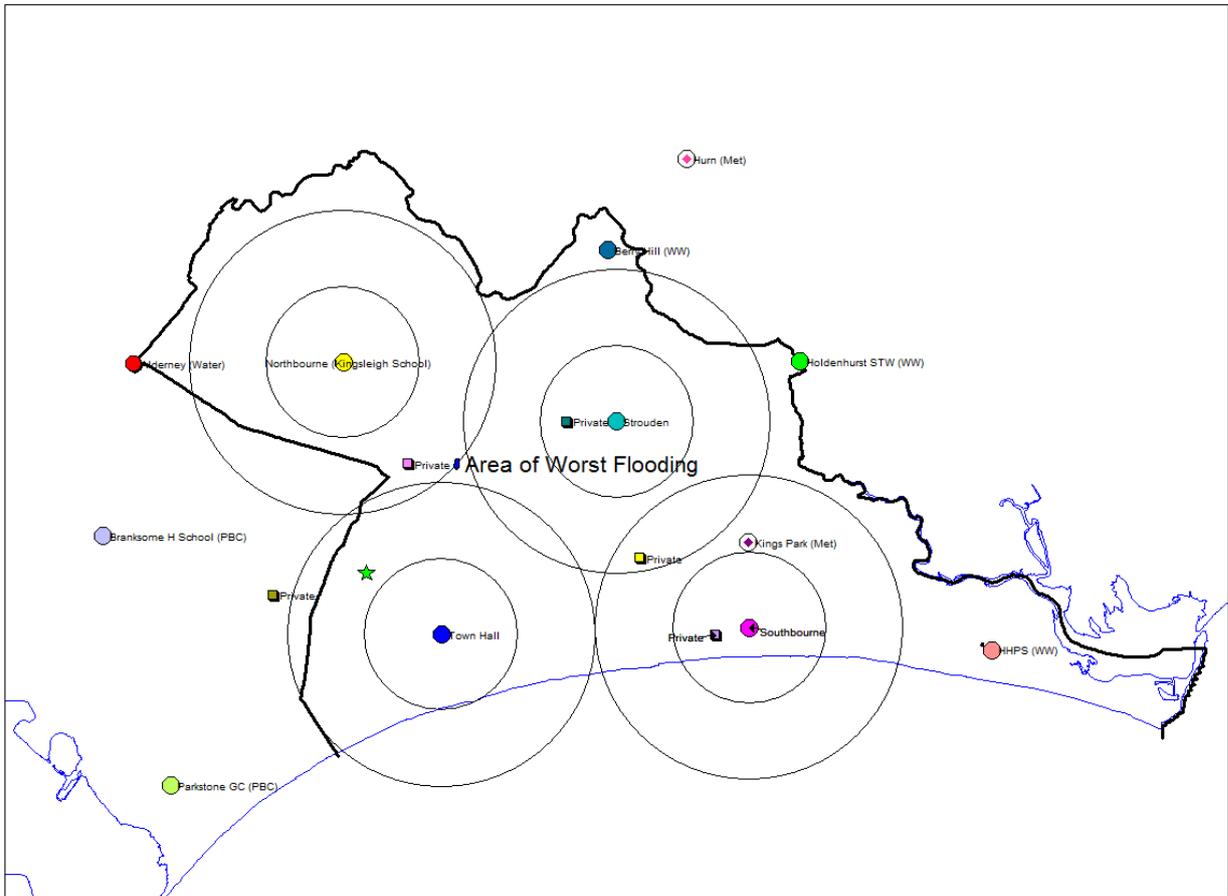
Existing Rain Gauges in and around Bournemouth (not to scale)

(Rings are 1km and 2km respectively from the Bournemouth Raing Guages. The private rain gauge which was near by does not seem to be currently reporting)

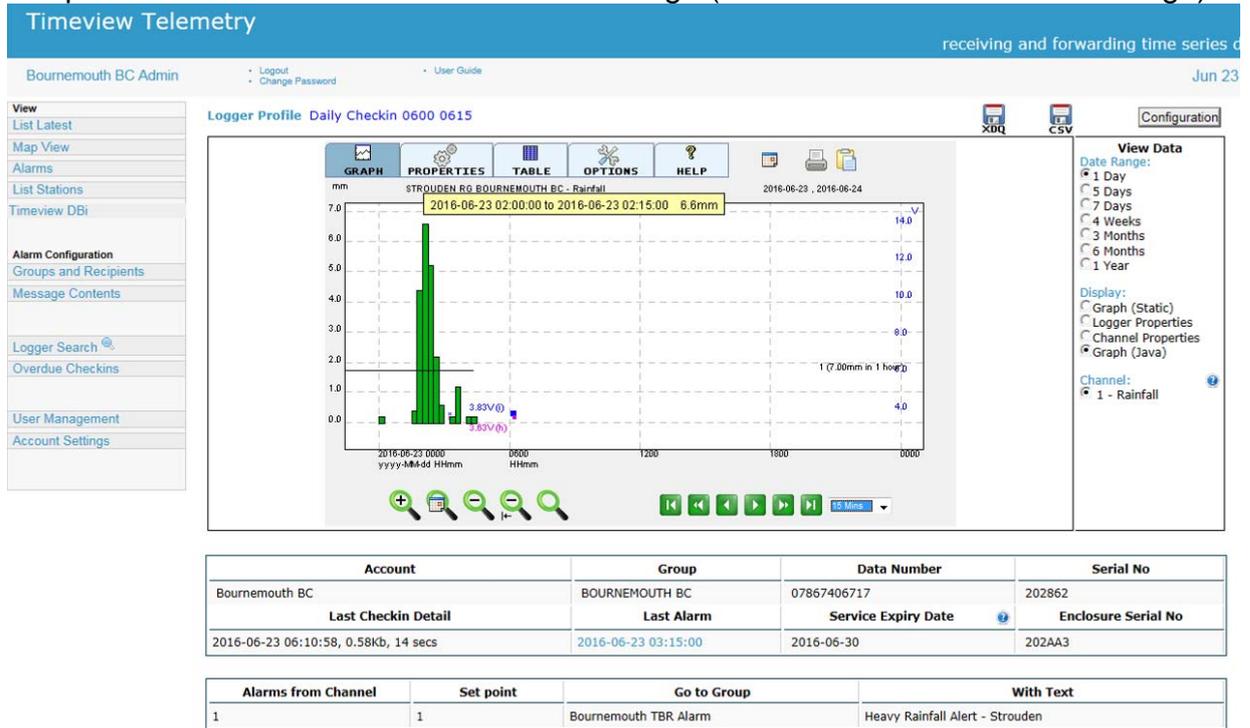
Snap shot of Bournemouth Strouden Rain Gauge (heaviest rainfall for a BBC Gauge)

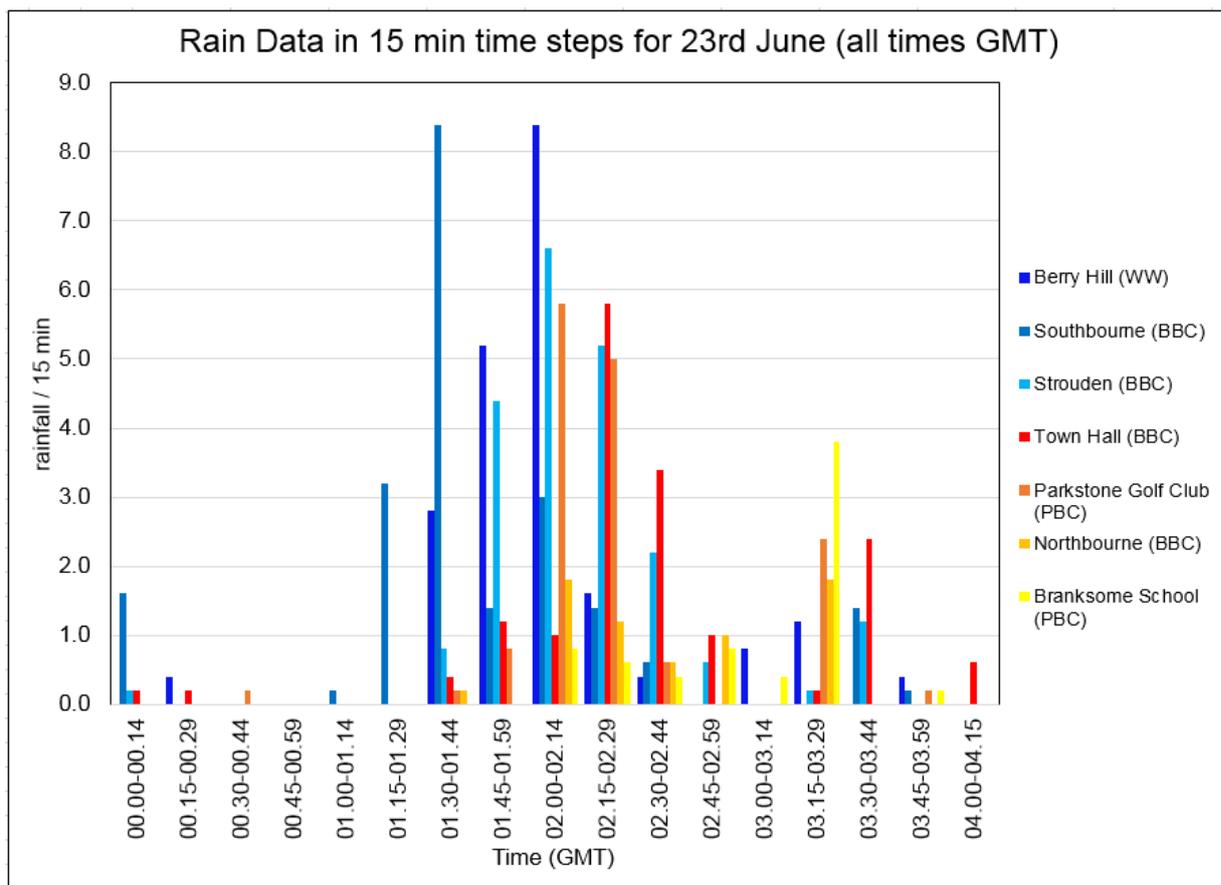
Rainfall from available gauges plotted in 15 min time steps

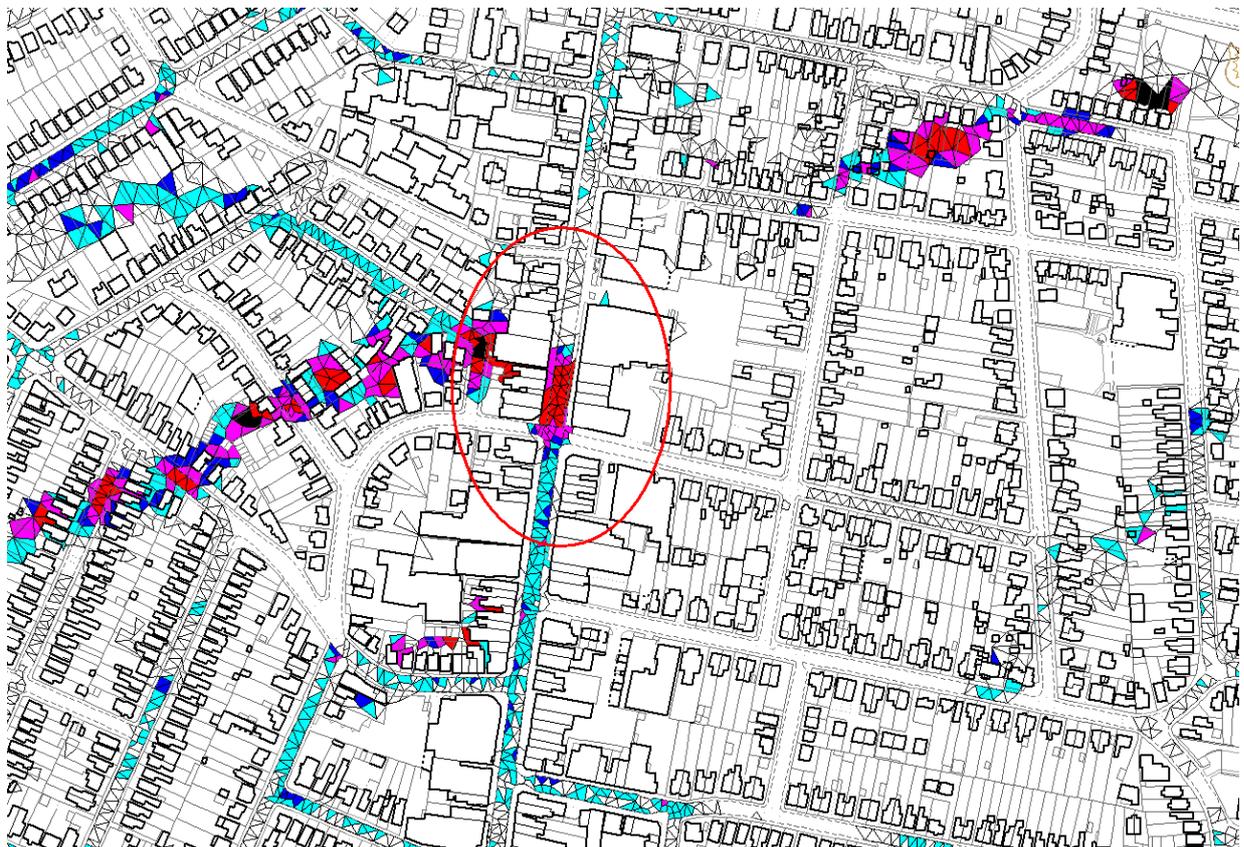
- 4.8 All the currently available surface water flood models show this is a high risk area. Below are the results for a 1 in 100 year storm using the latest available full Infoworks Model developed jointly with Wessex Water (The pale blue is depth 50-100mm, dark blue 100-150mm, purple 150-300mm, red 300-500mm and black exceeding 500mm).
