MUDEFORD SANDBANK – COASTAL PROTECTION REPAIRS 2021 – POTENTIAL IMPACT ON NESTING BIRDS

HIGHCLIFFE AND STEAMER POINT - COASTAL PROTECTION REPAIRS 2021 – POTENTIAL IMPACT ON NESTING BIRDS

FRIARS CLIFF AND AVON BEACH – COASTAL PROTECTION REPAIRS – POTENTIAL IMPACT ON NESTING BIRDS

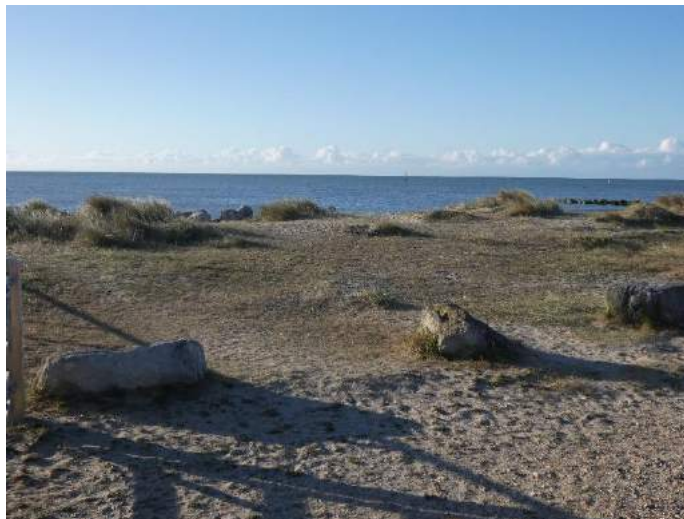
2.1 Fig 3 shows the intended compound area. This is an area of very short grass and bare sand just above high water mark with small clumps of slightly taller dune vegetation. The area is immediately to the south of the area fenced off and intended to be used for nesting and roosting birds. There is no scrub or other cover suitable for birds to conceal nests and the area is quite trampled and probably very disturbed by walkers (including dog walkers). It is unlikely that any ground nesting birds would use this area; the much larger fenced area to the north being far more suitable (it is believed a pair of Oystercatchers has attempted to nest within the fenced area in recent years).

Fig 3 – Proposed compound area

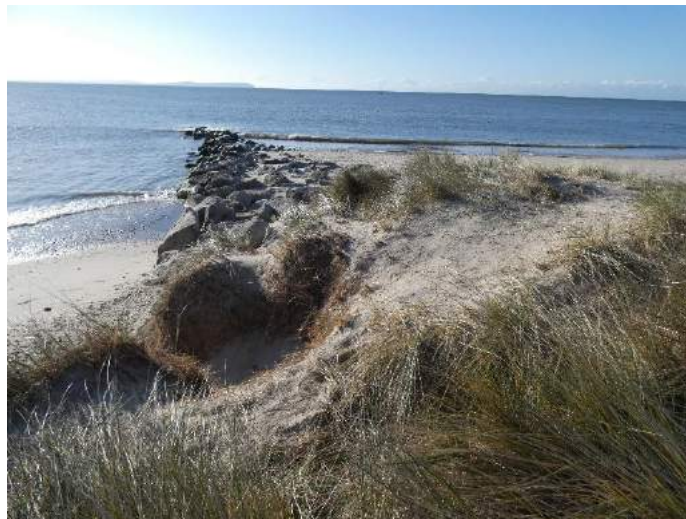
Fig 4 – Groyne S12

2.2 Fig 4 shows groyne S12, which is typical of the habitats found on the groynes due to be repaired (groynes S10-S13). The lower parts of these groynes are often under water at high tides and the beach levels are such that the height of the rock structure above the beach is relatively low, rising to the landward end where sand has accumulated over the groyne and sparse pioneer dune vegetation is present. The rocks forming the groynes are large and provide few secure potential nest sites. There is open public access and levels of disturbance by people and dogs is likely to be high. Whilst it is possible that birds could attempt to nest on the groynes it is thought unlikely that this would occur given the structure and character of the habitat.

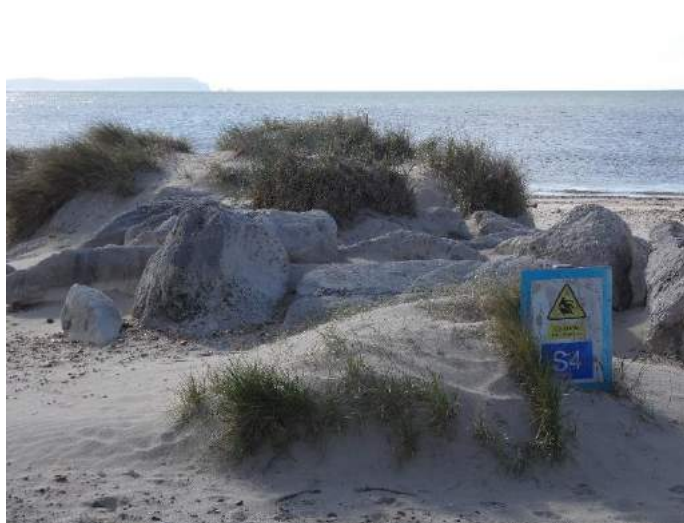
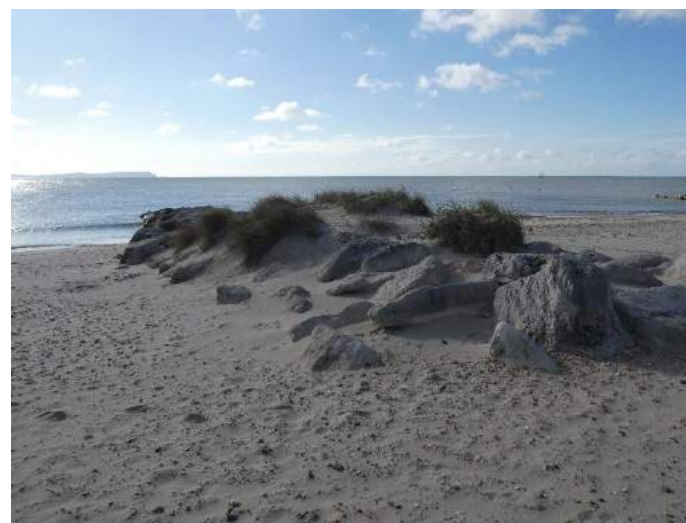
2.3 Figs 5 and 6 show groyne S4. This is typical of groynes S1 -S9 which are due to have the markers at the seaward ends replaced.

Figs 5 and 6 – landward end of groyne S4

The sites for the groyne markers themselves are often submerged by the tides with no scope for birds to nest. Beach levels are also high here and with the groyne (and associated vegetation, when present) are relatively low. No scrub is present in these areas and cover is extremely limited. It is considered that there would be few potential nest sites

for birds. If it is necessary to ramp beach material over the landward end of the groynes this is unlikely to affect any nesting birds.

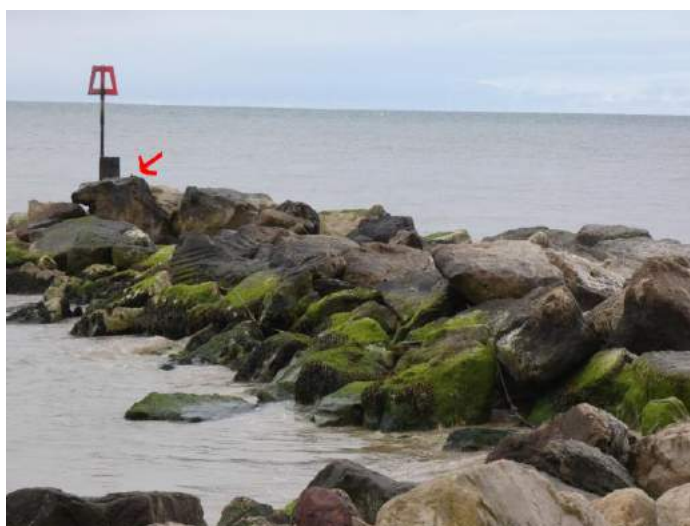
1 present on groyne S1 from 06:20 to 07:06. Initially this bird was resting on a large rock close to the groyne marker, the rock being within the splash zone though the tide was low at the time (see Fig 7), the bird subsequently moved to a lower part of the groyne and could be seen feeding amongst the green algae (Fig 8). It then sang briefly (also undertaking a song flight) and then flew towards the groynes to the south.

Fig 7 – Initial location of Rock pipit on groyne S1 (shown by red arrow) 19th May 2021

3.3 The behaviour of the Rock Pipit seen on 19th May 2021, suggests a bird holding territory, though there was no indication of nest building, an occupied nest or the bird feeding young. From the observations made in 2.2 and the structure of the groyne shown in Fig 7, it is felt unlikely that a nest is situated on groyne S1 itself (or on groynes 2-13, which are subject to the proposed works). It may be significant that both birds recorded on 19th May 2021 were seen to fly off southwards towards Hengistbury Head and it is possible that a nest is located in that area.

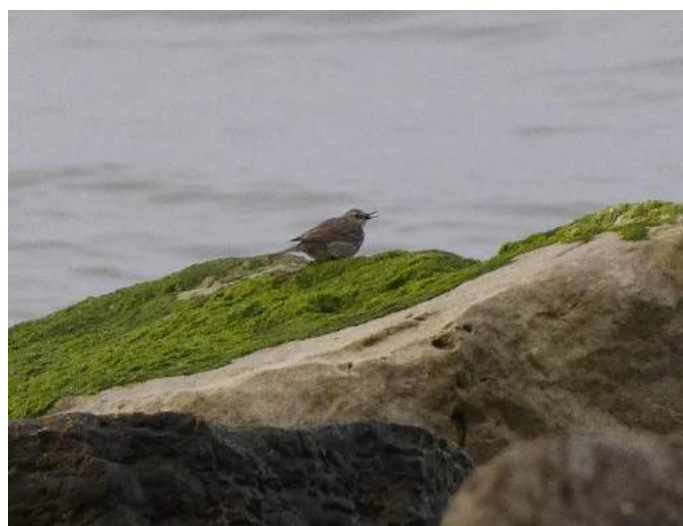
Fig 8 – Rock Pipit foraging on algae on groyne S1 19th May 2021

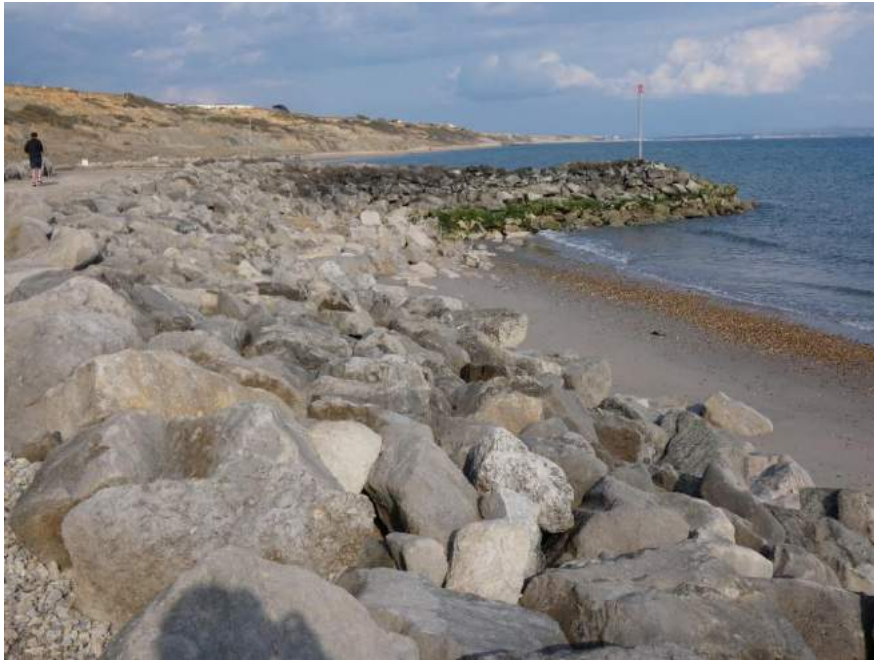
8.1 Figs 11 / 12 and 13 / 14 show representative sections of the groynes and rock armour of the Steamer Point footpath respectively. It can be seen that the structures are composed of relatively large, irregularly shaped blocks of stone. Although there are crevices allowing access into the structures and almost certainly voids within them, the size of the rocks mean that these would not provide protection from predators. The structures are largely devoid of vegetation and are surrounded by shingle or sandy beach material with very little vegetation. Sea levels are such that the strand line and splash zone are quite high up the groyne (see Fig 9). The rock armour at the Steamer Point footpath is several pieces of stone high at the west end (Fig 13) but virtually at beach level at the east end and for much of its length (Fig 14).

Fig 11 – General structure of groynes

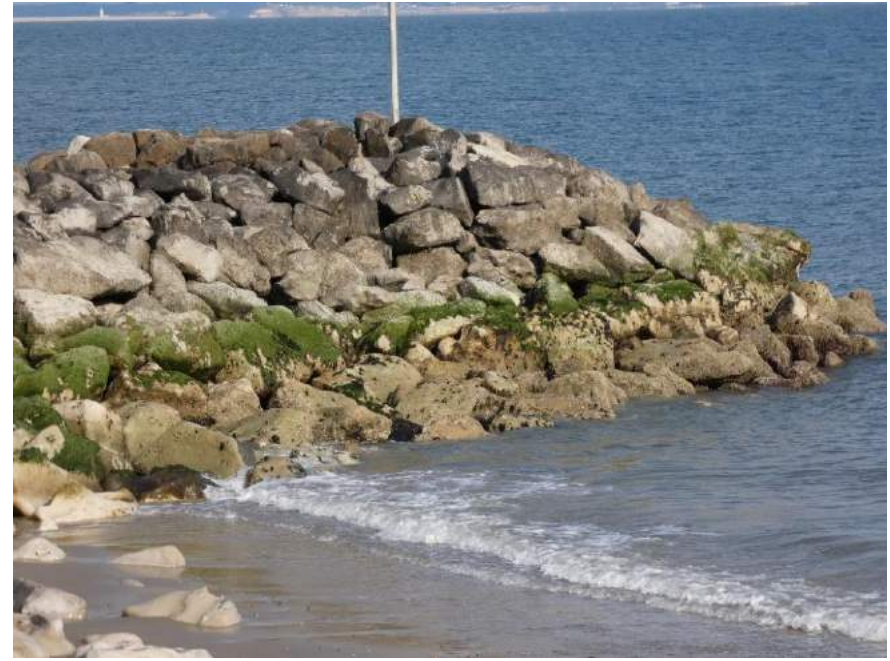
Fig 12 – Detailed structure of groyne

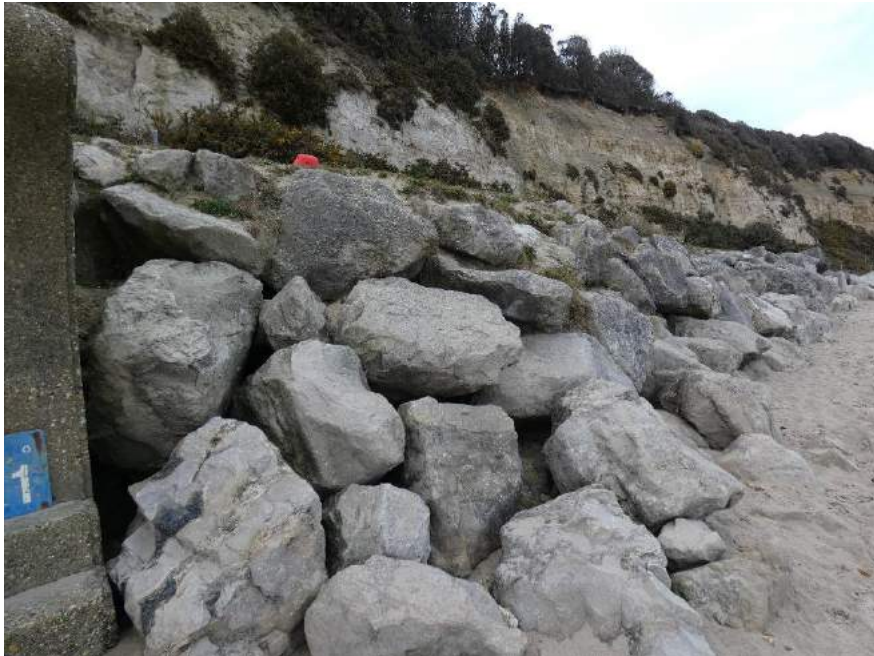
Fig 13 – Rock armour of Steamer Point footpath (west end)

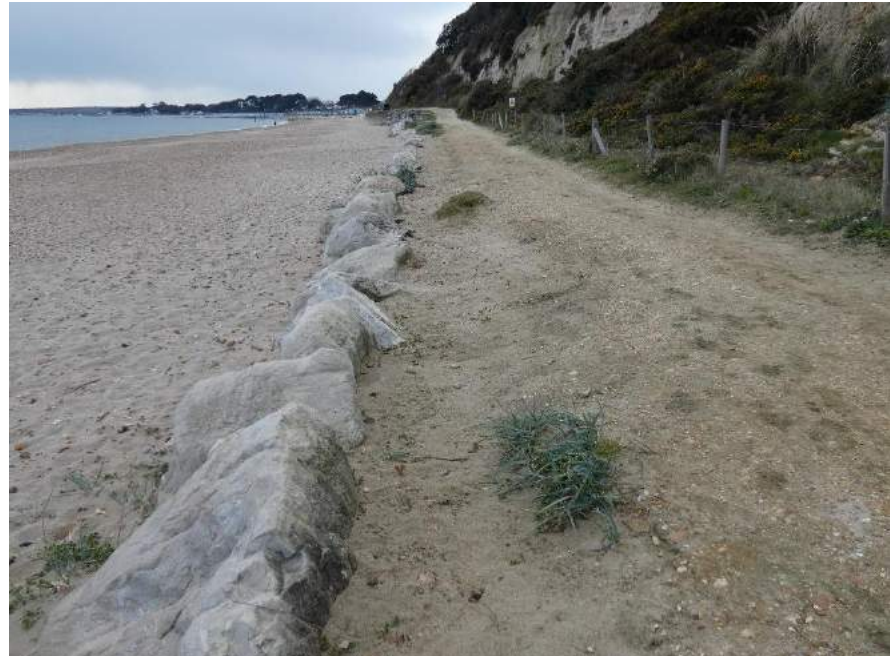
Fig 14 – Rock armour of Steamer Point footpath (east end)

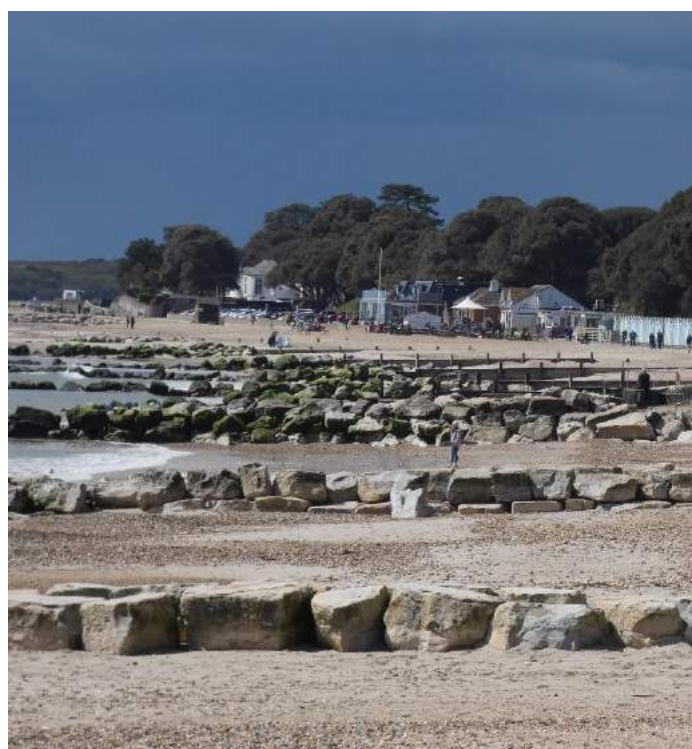
11.1 Fig 16 shows a view along the beach and the general character of the groynes. Fig 17 shows the structure of one of the more substantial groynes. As anticipated, it is evident that much of the seaward end of the groynes are underwater at high tides. The higher parts of the groynes are composed of relatively large rocks but with very limited height overall height above current beach levels. Whilst there are gaps between the rocks and potentially voids within which birds could nest in, such sites would be very vulnerable to disturbance and predators. The groynes and adjacent areas are almost completely devoid of vegetation and there is little cover to conceal nests.

Fig 16 – general view of groynes at Avon Beach

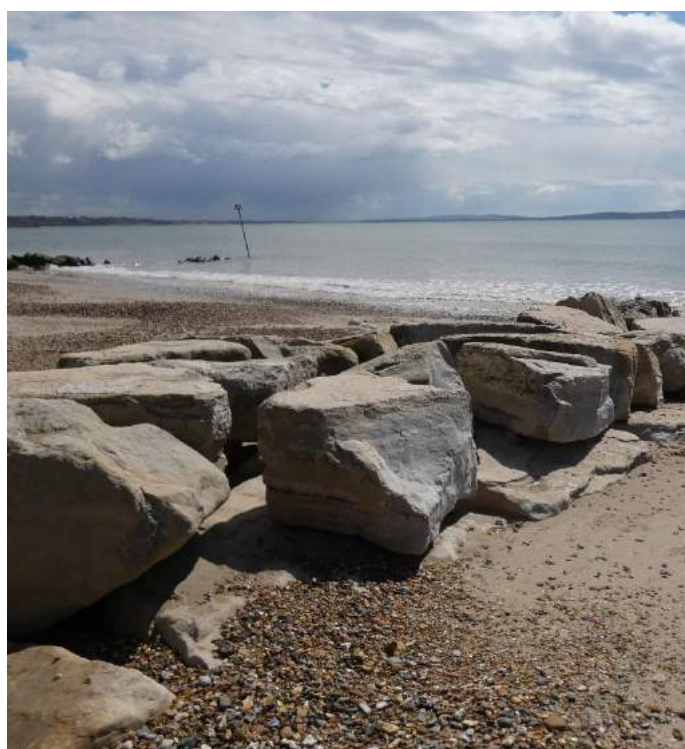
Fig 17 – detail of typical groyne at Avon Beach
