SANDBANKS COAST PROTECTION

**David Robson, Senior Engineer, Coastal & Drainage Team
Borough of Poole Leisure Services**

May 2003

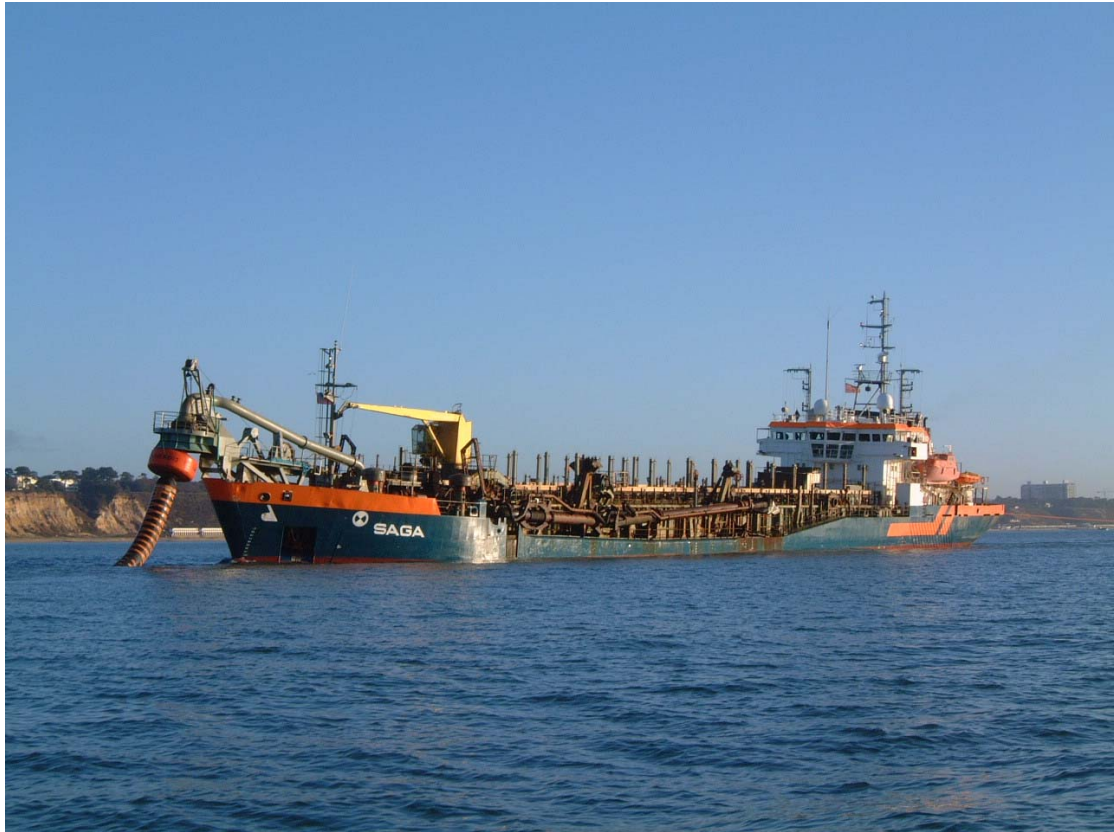
Dredger Saga with pipeline pumping material to shore

A 750m long, 800mm diameter pipe was towed in three sections to the site by sea to connect from the dredger to the shore. The depth of the water restricted how close to the shore the dredger could operate.

The "Saga" a trailer suction hopper dredger commenced work on the 3 March 2003 material placed on the beach was dredged from the Main Swash Channel and the Middle Ship Channel. The dredger would collect material from one of the locations and then sail to the end of the pipeline located off the beach. Connecting to the pipeline the material would then be pumped ashore from the dredger's hold and it would return to the channel to dredge more material. The whole round trip took an average of 3-3½ hours. This process was repeated a total 71 times with the dredger operating 24 hours a day, each load was on average 1,830m³. The dredging was completed on 17 March 2003.

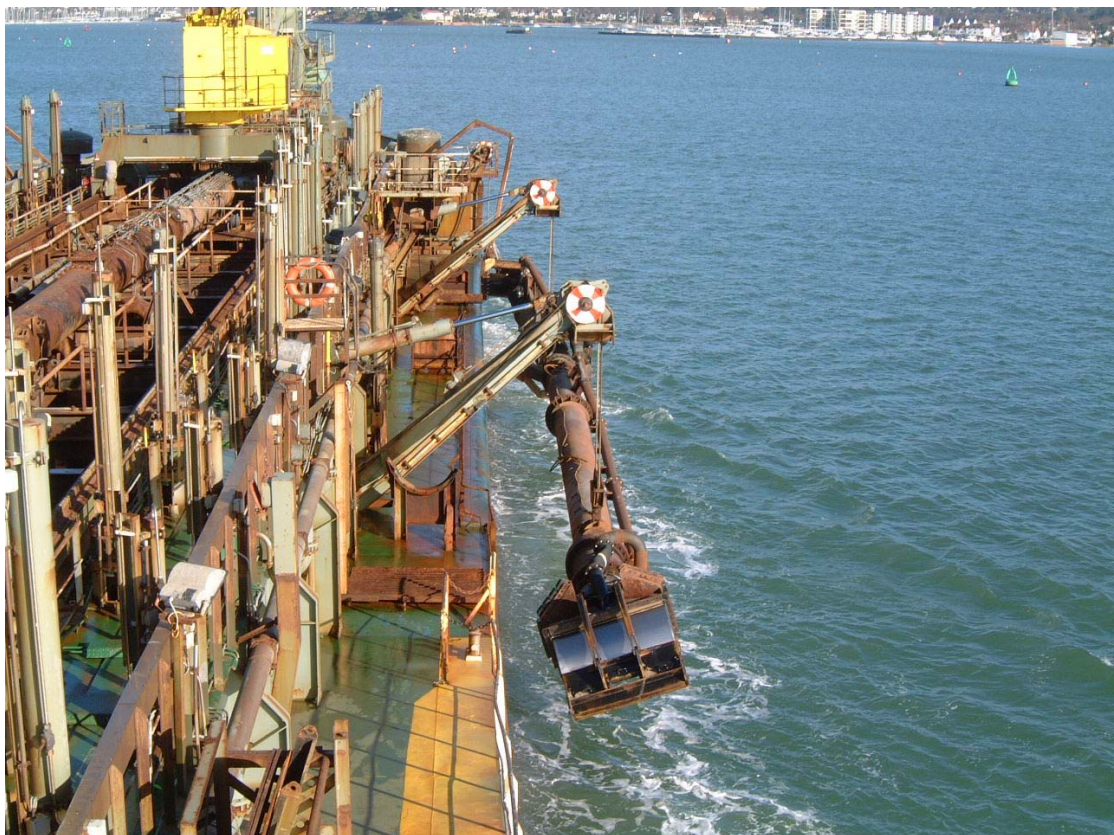
Suction “arm” on dredger about to be lowered to start dredging

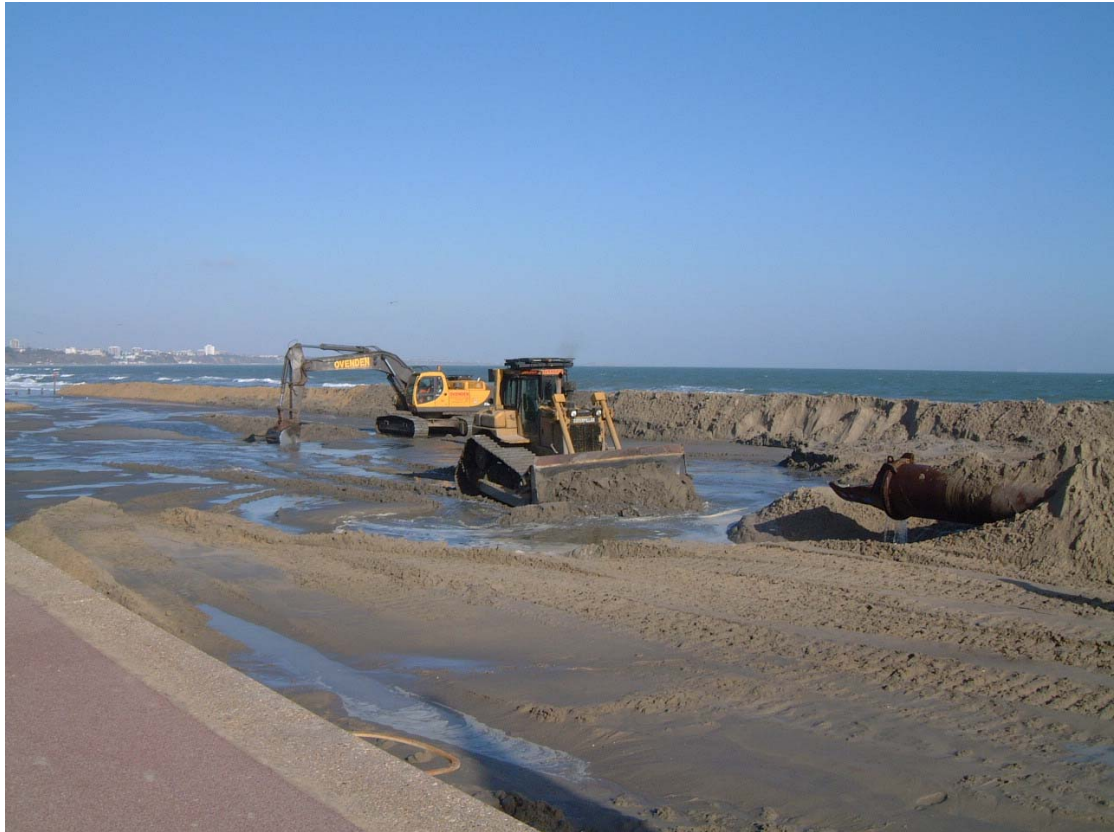
Creating lagoon to discharge material on shore

These sections of pipeline were placed parallel to the sea wall. Sand bunds were formed towards the sea side to create a lagoon in order to retain the sand on the beach

and avoid losses of sand to the foreshore. The sand/water mixture from the pipeline flowed in behind the bund where the sand settled out on the beach and the water returned to the sea at the end of the lagoon.

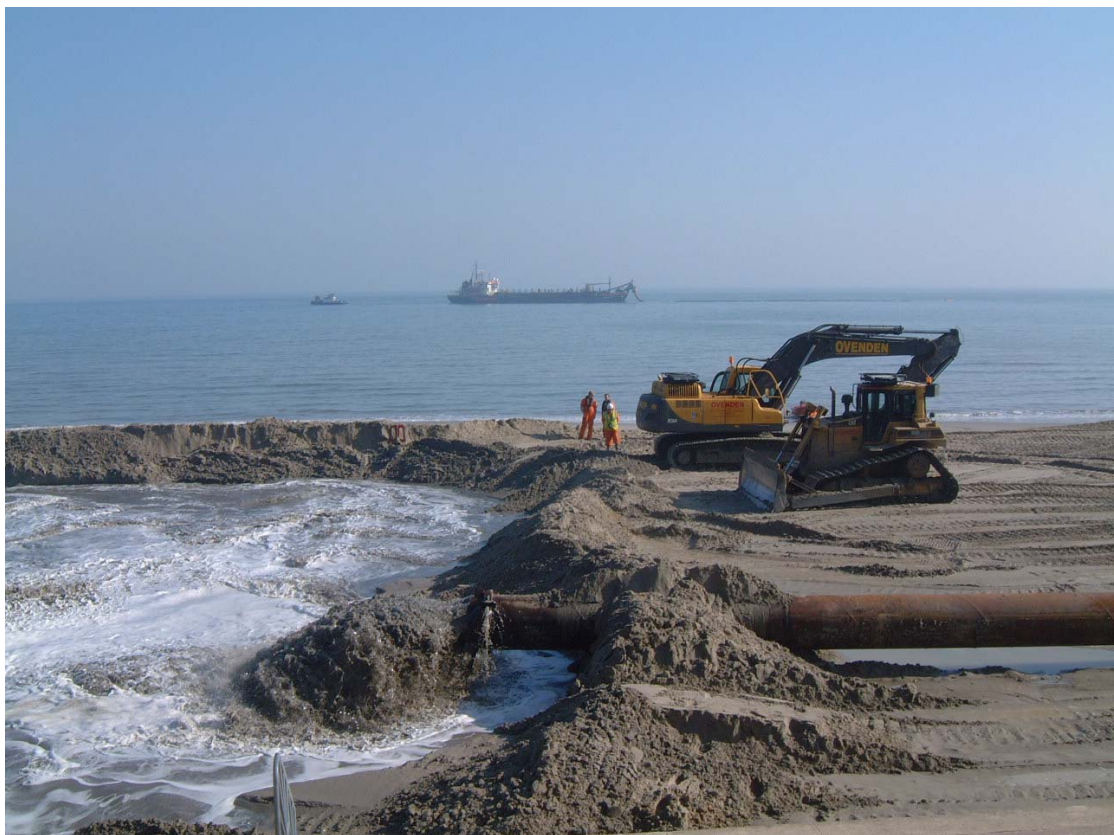
Material being pumped ashore

At the landward end of the pipeline coming to shore a "Y" section was fitted with a valve on each arm of the Y. Connecting 12m lengths of pipeline to either side of the Y material was then pumped in each direction along the length of the beach.

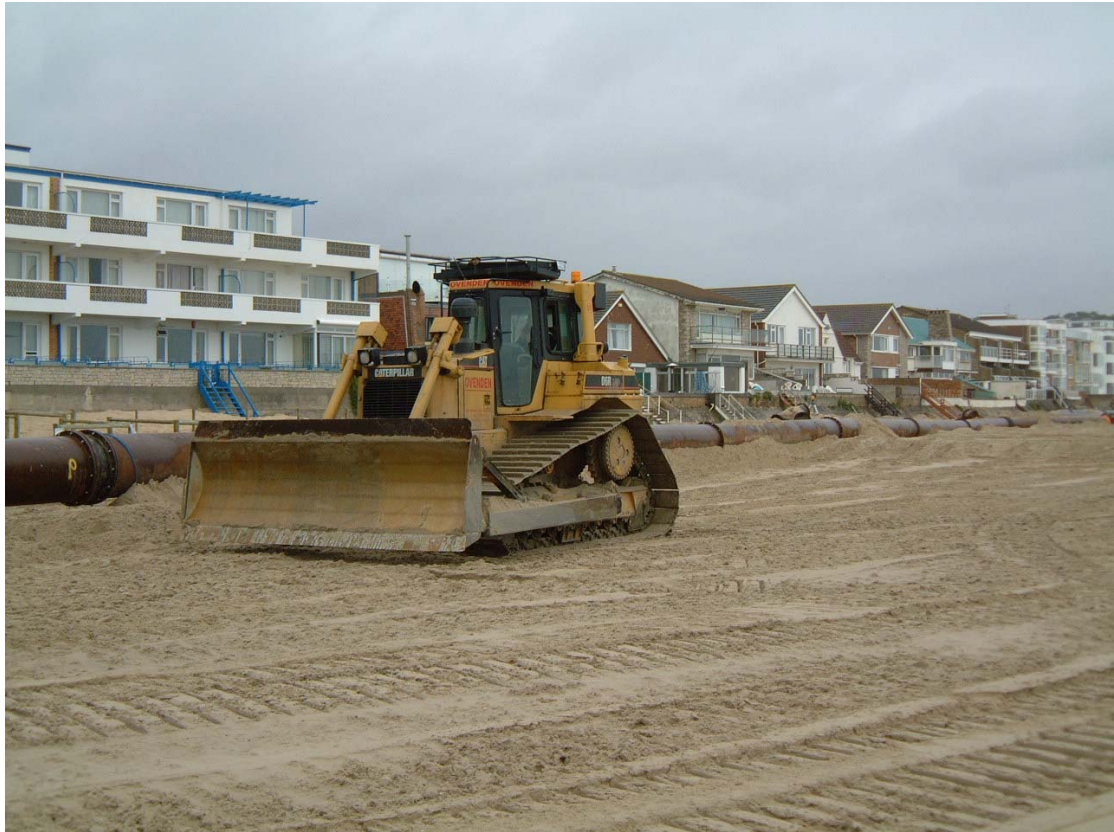
Bulldozer levelling beach

A bulldozer was then employed to profile the sand on the beach to the required level.

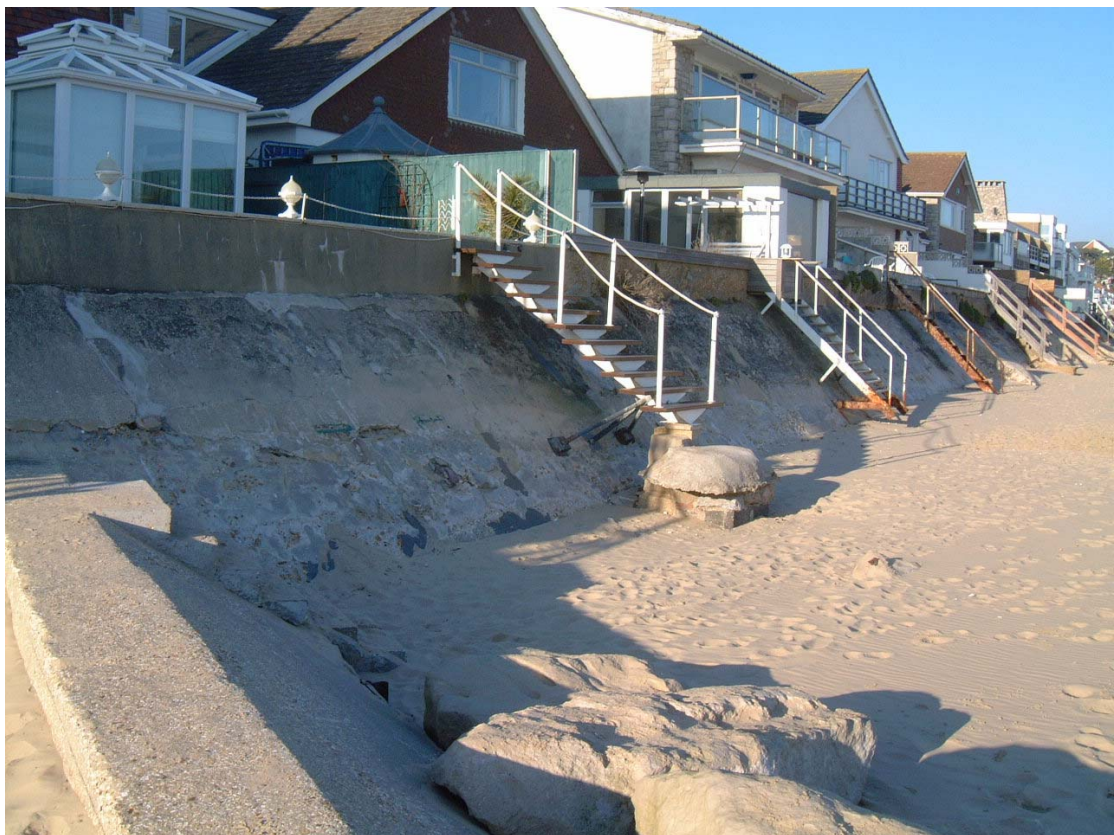
Beach before works

Why - Although the erosion at the western end of Sandbanks is now managed by the recently constructed groyne it has continued in the central and eastern end. This has resulted in the lowering and narrowing of the beach. It was considered that during prolonged stormy conditions the concrete sea wall could be under threat of damage or collapse.

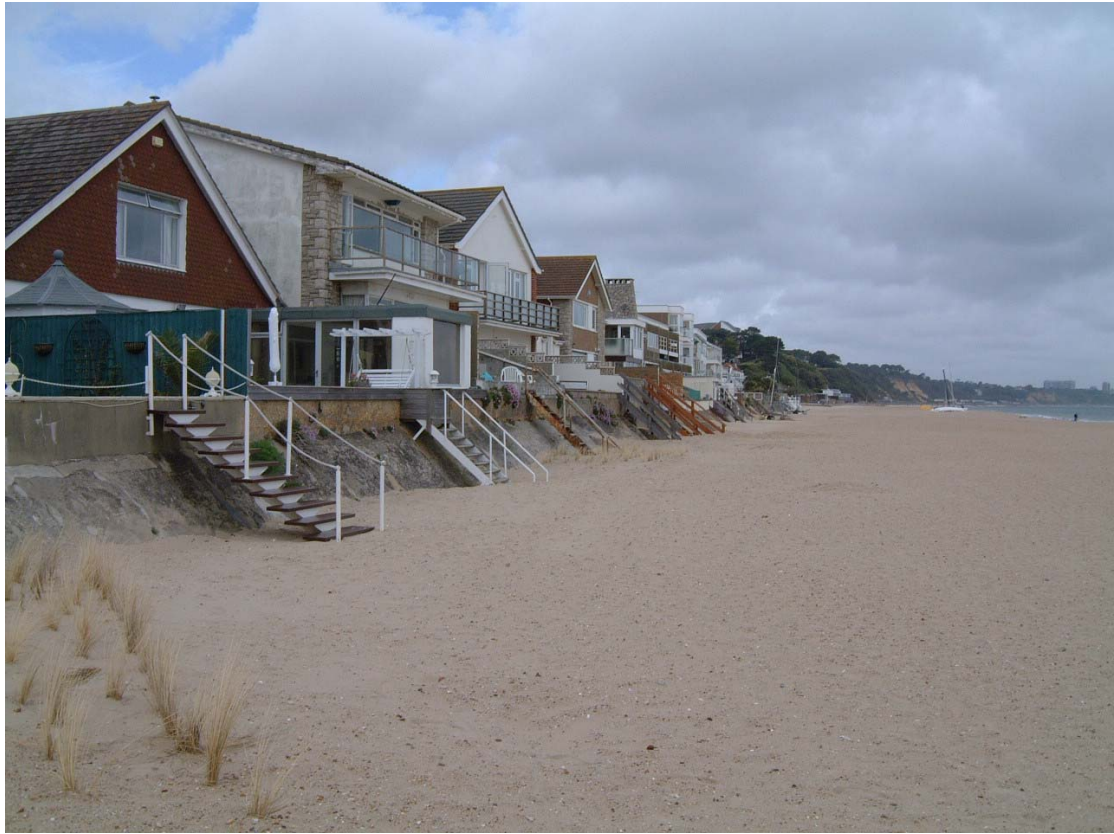
Beach after works

The total length of beach re-nourished was 1020m, increasing the width of the beach by an average of 50m.
