SCOPAC Sand Dunes Study

Sand Dunes at Sandbanks, Poole:
Background, Evolution and Future

BCP Council

09 September 2020

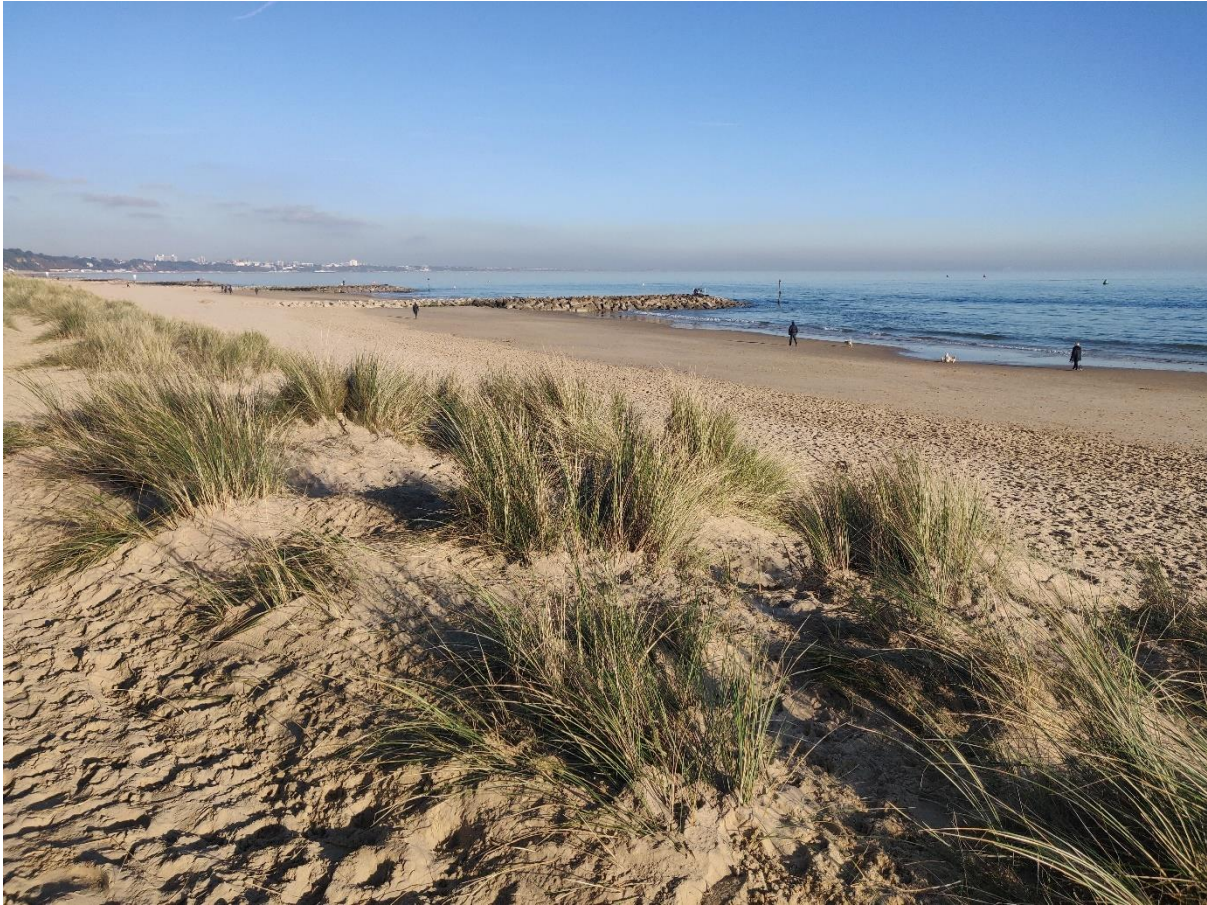
Figure 1 Sand dunes at Sandbanks (photograph taken by Lia Bennett).

This investigation focuses on the dune system on the Sandbanks Peninsula (Figure 1), a sand spit located on the east side of the entrance to Poole Harbour, at the western end of Poole Bay in southern England. Historically, the majority of Sandbanks consisted of sand dunes but due to residential development and beach erosion they had been depleted considerably. As a result, the Sandbanks Coast Protection Scheme was constructed in two phases between 1995 and 2001. Phase 1 (1995/6) involved construction of four rock groynes and regeneration of approximately 1,200m² of new sand dunes by planting marram and Sea Lyme grass. Phase 2

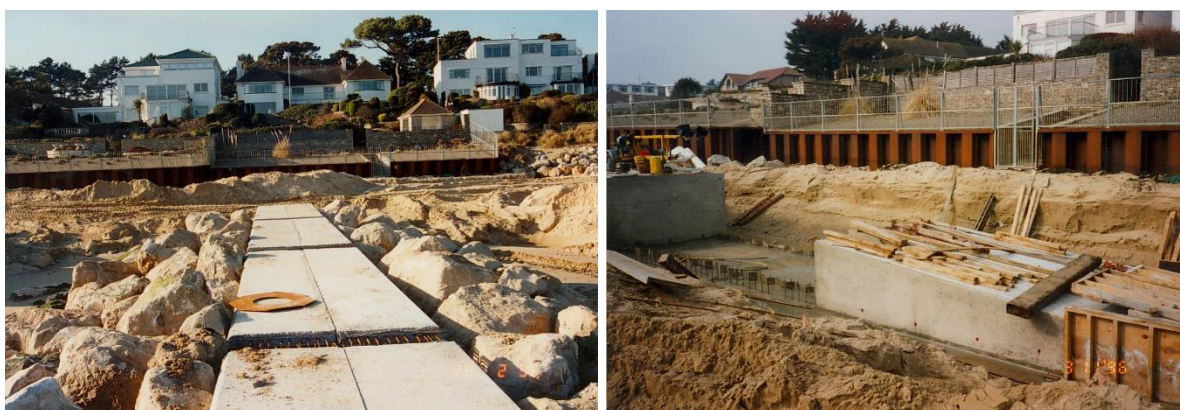
Figure 6 The construction of concrete walkways on groyne structures installed at Sandbanks.

Most of the rock used for the groyne was 3-6 tonne Portland Limestone which was delivered to site by road transport. A concrete walkway section was also constructed along the rock groyne for increased safety, the creation of which can be seen in Figure 6 below. Rock groynes were chosen for reasons of sustainability and design life economics (lifespan of at least 50 years), whilst more technically feasible than offshore breakwaters, the latter of which would not have achieved the desired results due to the offshore tidal conditions caused by the Harbour entrance.

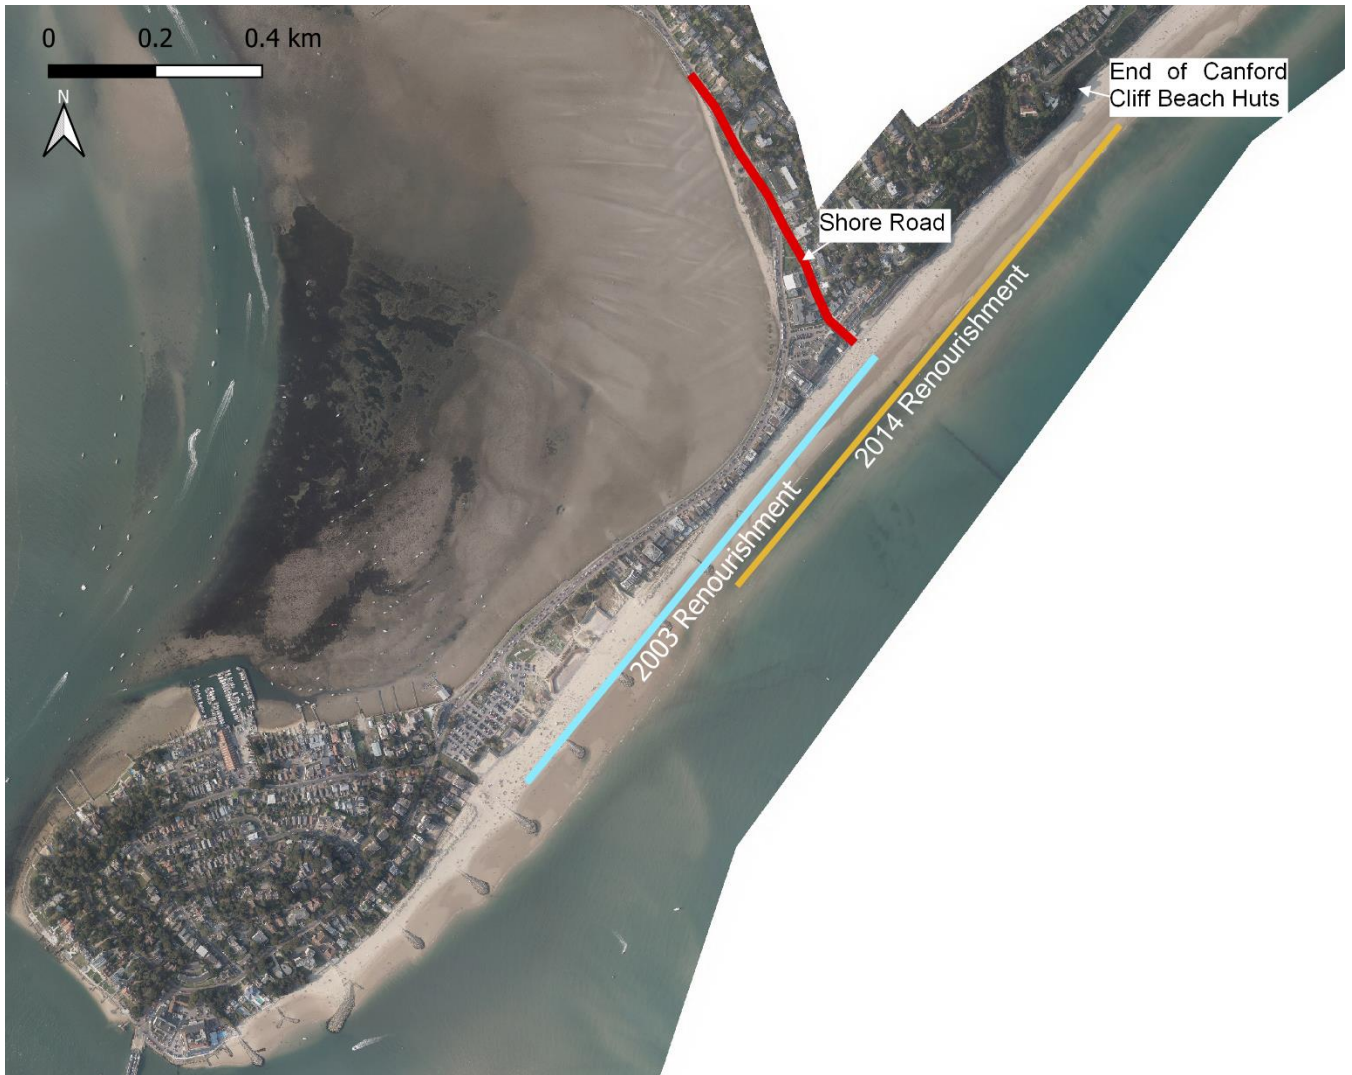
Figure 7 Overview of features at Sandbanks, including the extent of two renourishment schemes in 2003 and 2014.

Post-construction phases described above, an approx. 700m section of beach further eastward continued to erode and put properties at risk. Therefore, beach replenishment was carried out in 2003 and 2006 with 105,000m³ and 450,000m³ sand respectively placed onto the beaches of Poole during these operations (the 2003 works focusing more on Sandbanks). The total length of beach re-nourished in 2003 was 1,020m, between Sandbanks and Shore Road (the location of which is shown in Figure 7), increasing the width of the beach by an average of 50m. The results of these works pre and post replenishment can be seen in Figure 8 below (Robson, 2003).

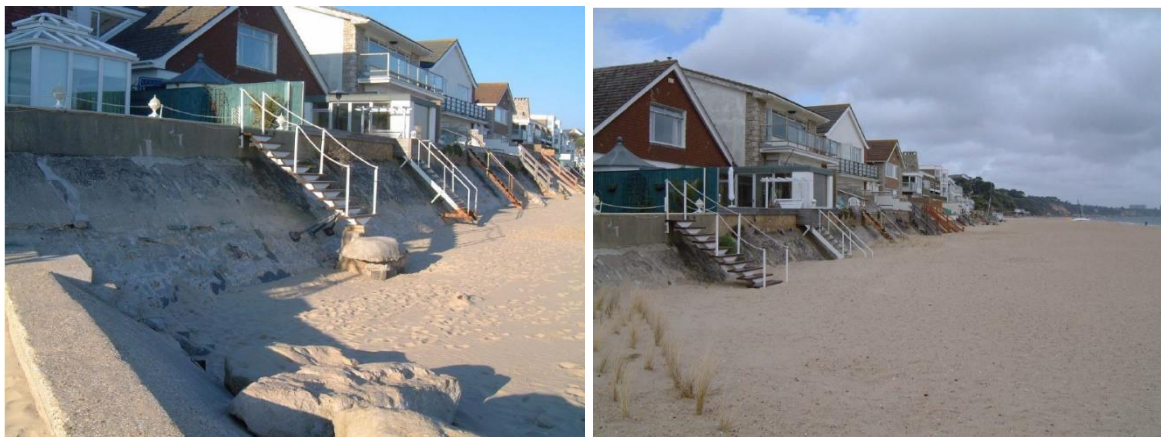
Figure 8 Before (left) and after (right) beach replenishment was carried out at Sandbanks in 2003, showing a large elevation in beach level (Robson, 2003).

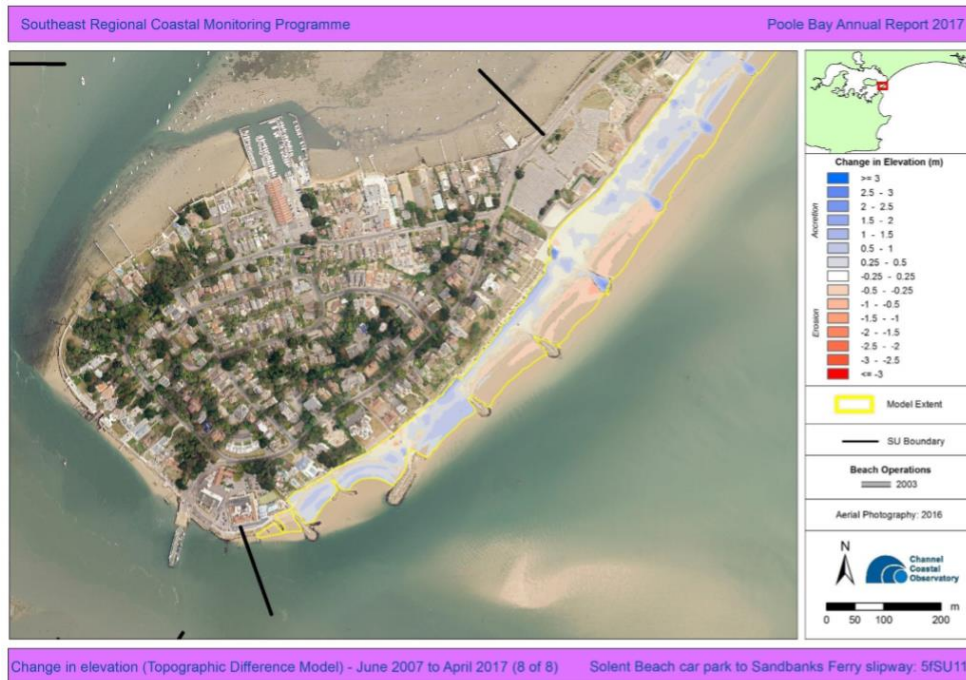
Figure 9 Topographic difference plot: Sandbanks peninsula - elevation changes June 2007 to April 2017 (CCO, 2017).

This section reviews information from the Channel Coastal Observatory Annual Reports, as well as recent photo observations. A net gain in beach levels and profiles across the period of 2007 to 2017 is evident from Figure 9 and Figure 11 respectively. Between 2003 and 2007, as shown in Figure 10, the cross-sectional area of profiles showed less accretion than in more recent years, with decreases in certain areas.

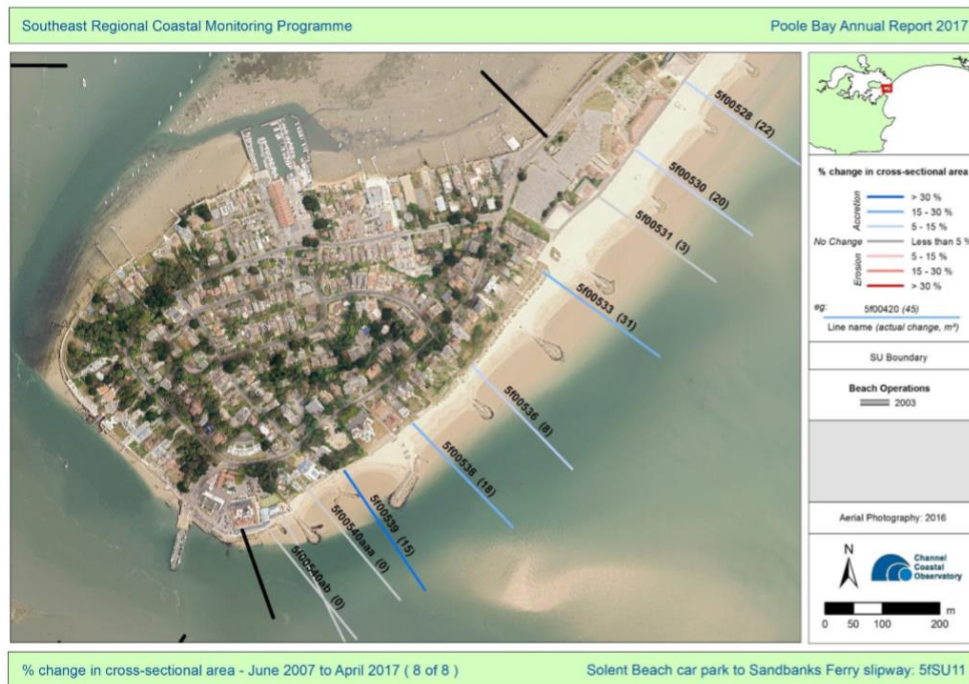
Figure 11 Percentage change in cross-sectional area at profiles- June 2007 to April 2017 (CCO, 2017).

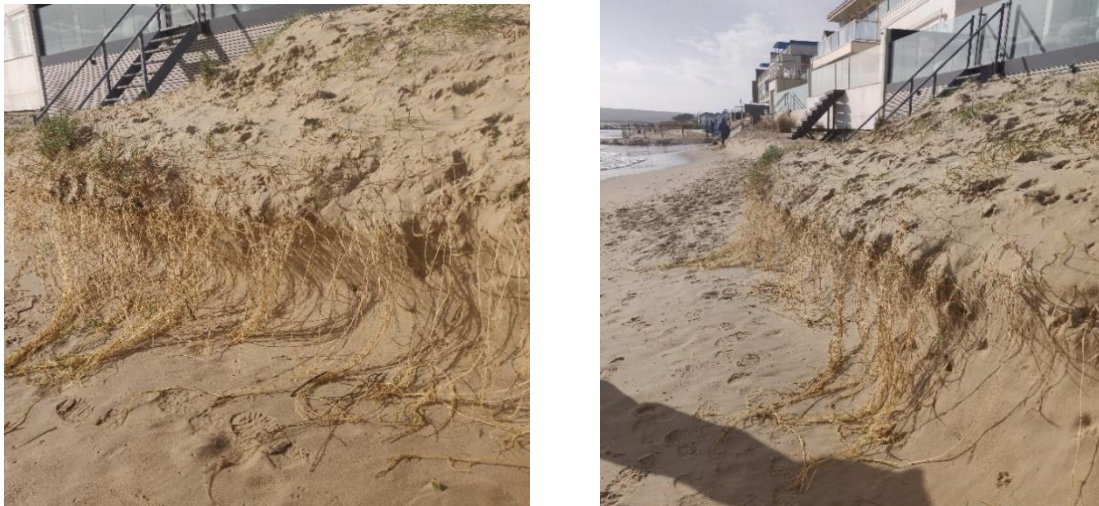
Figure 13 Undercutting at Sandbanks post storm Ciara on the 9th February 2020 (Photographs taken by Lia Bennett).

The net gain between 2007 and 2019 is despite the 2013/14 winter storms where, just north of the peninsula, a significant amount of sand was lost (Figure 12). In response to this, in December 2014 139,000m³ of sand was delivered to the frontage from Sandbanks rock groyne to the end of the beach huts at Canford Cliffs (www.poolebay.net), the extent of which is shown in Figure 7. Recent storms have also been observed to cut back the dunes rapidly, such as storm Ciara in February 2020 which resulted in undercutting; as shown in Figure 13. These

photographs show that there is a well-developed root structure present in the dunes, providing strength as shown by the cliffed profile of the sand.

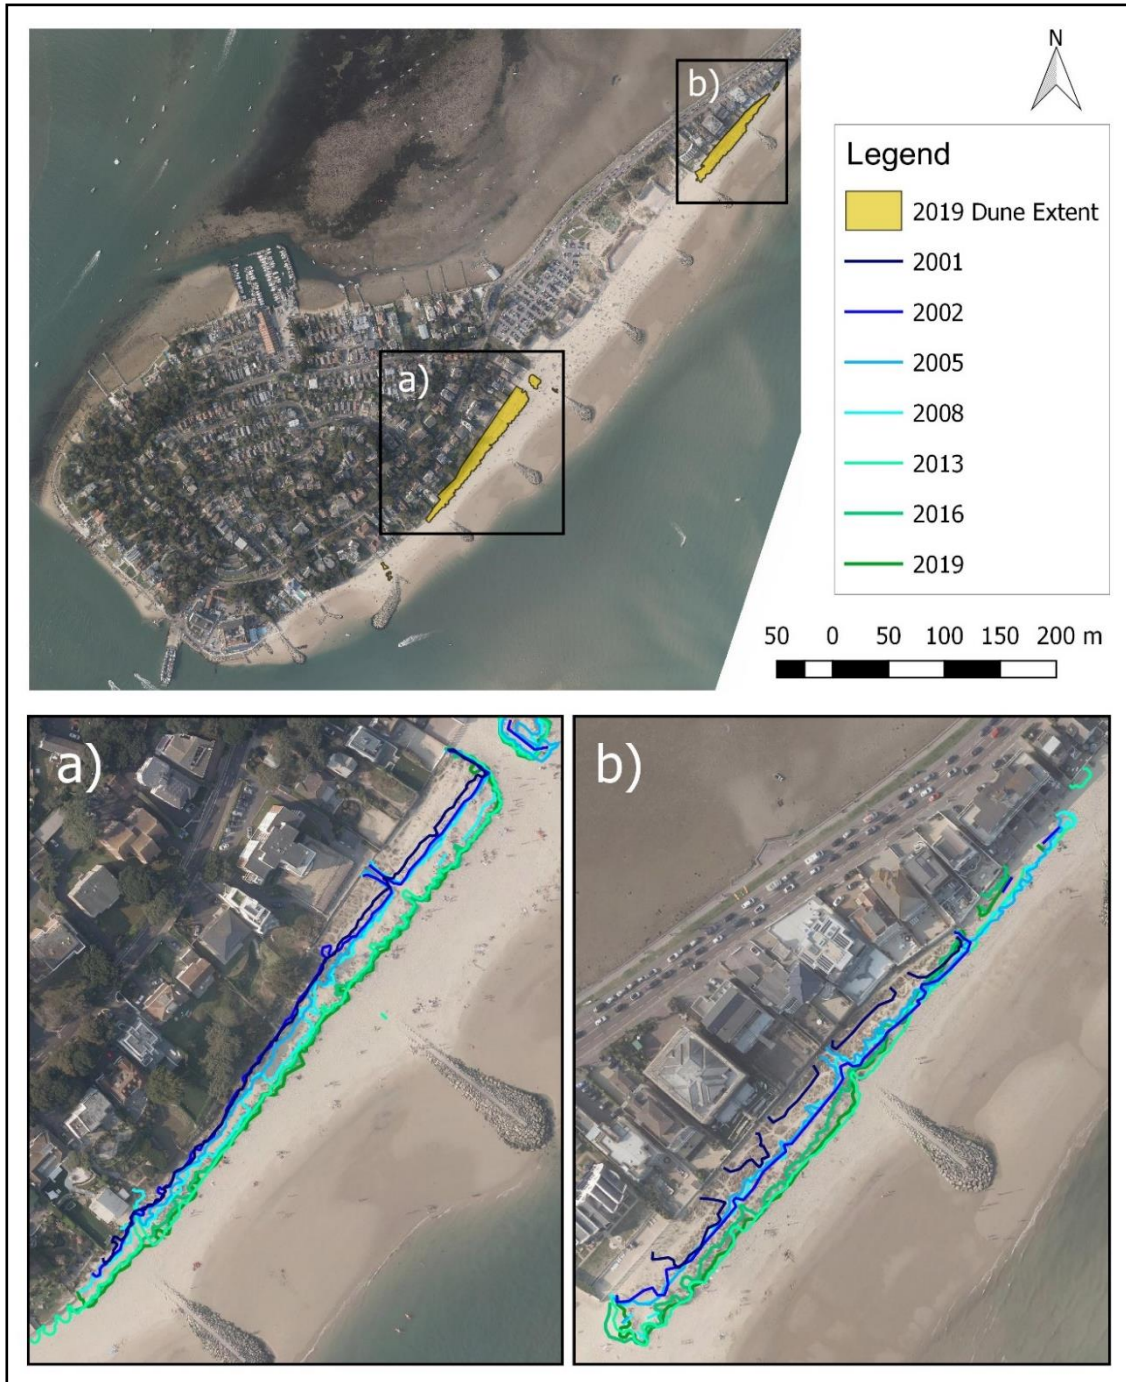
Figure 15 Dune outlines for each aerial photo at Sandbanks.

As indicated in Figure 15, the dunes have spread both seaward and laterally. *Another note for future analysis would be to compare different lateral vs. cross-shore progression of dune systems in different case studies.*

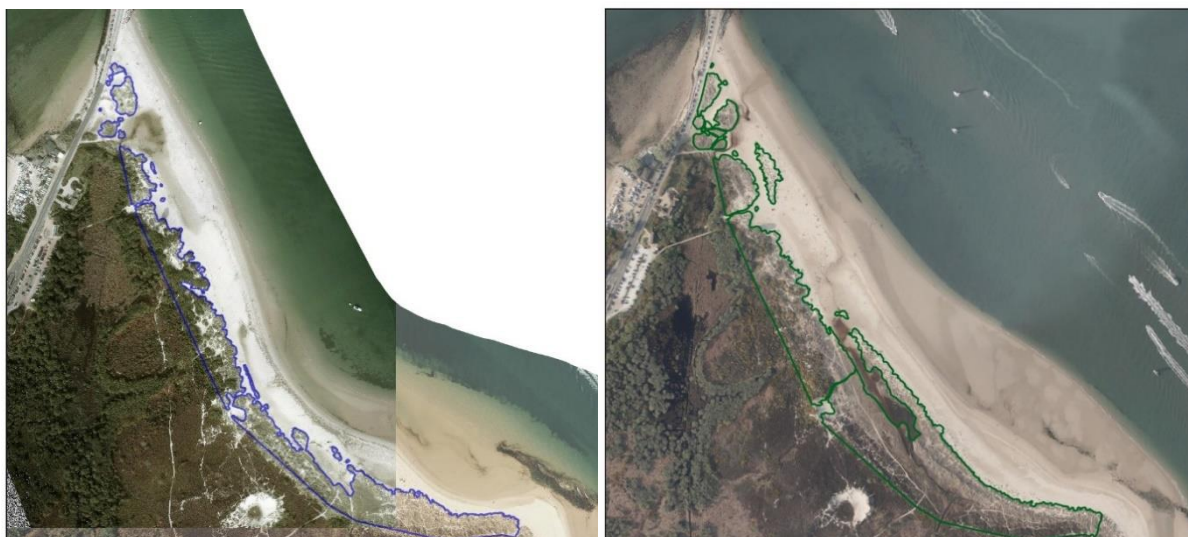
Figure 16 Dune vegetation at Studland (left 2001 and right 2019).

Interestingly, over the span covered by this study the Studland dune system appears to have advanced seaward and grown in area by over 24,000m³, with an acceleration in growth over the period 2008 and 2016 (black line in Figure 14). Note, the areas captured are relative: for the analysis and consistency, the digitisation of the landward dune area was fixed as constant in the aerials (Figure 16).

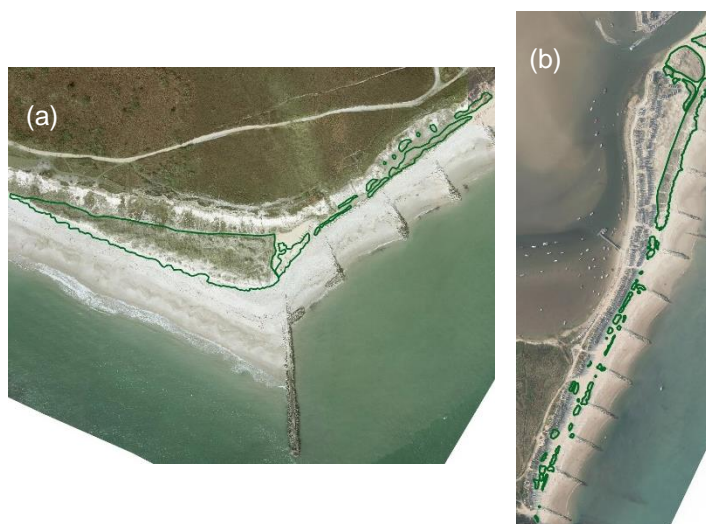
Figure 17 Dunes at (a) Hengistbury Head and (b) Mudford Sandbank in 2019.

Mudford Spit is 900m long and hosts dunes up to 7m high. The width of these dunes has in the past increased markedly, from an average of 50m in 1840 to 300m in 1885, owing to a surge of sediment supply from Hengistbury head due to ironstone mining which exposed more fine sediment (BBC, 2005). The results here suggest the dunes have expanded by around a third in area over 2001 to 2019, the latter of which is represented in Figure 17(b).

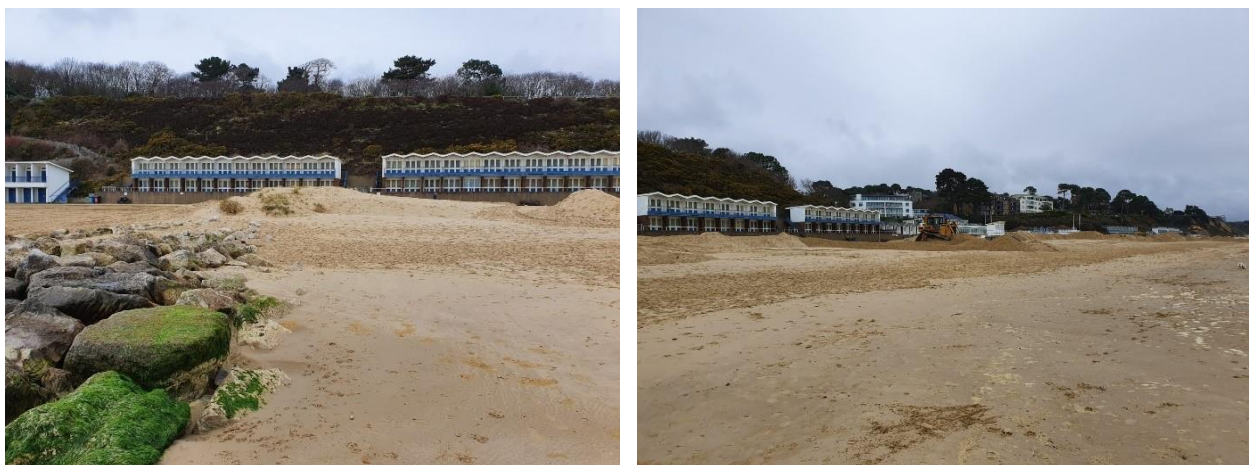
Figure 19 Dunes at Branksome being driven over during promenade clearing in March 2020.

respond to interference. As noted in Figure 19, during a major promenade sand clearance operation, bulldozers drove over the dunes. Their recovery after this and in response to the upcoming (autumn/winter 2020) beach replenishment, should be assessed in future work.
