MUDEFORD SANDBANK – COASTAL PROTECTION REPAIRS 2021 – POTENTIAL IMPACT ON NESTING BIRDS

HIGHCLIFFE AND STEAMER POINT - COASTAL PROTECTION REPAIRS 2021 – POTENTIAL IMPACT ON NESTING BIRDS

FRIARS CLIFF AND AVON BEACH – COASTAL PROTECTION REPAIRS – POTENTIAL IMPACT ON NESTING BIRDS

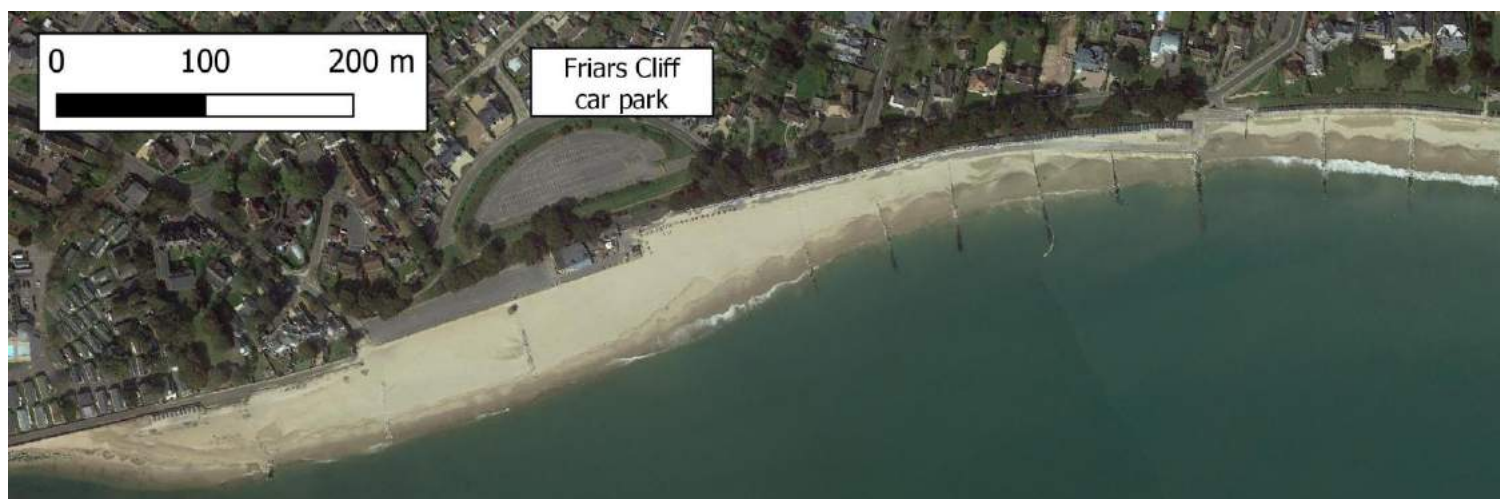
Fig 15 – Current Google aerial photograph of shoreline at Friars Cliff – Avon Beach

11.3 The only birds observed on the groyne or nearby beach were House Sparrows, Black-headed Gulls, Herring Gulls and a single Carrion Crow. The House Sparrows were foraging around the high-tide line on the groynes, whilst the Herring Gulls were feeding on a washed-up fish and the Black-headed Gull were close to people eating on the beach. None of these birds showed any evidence of nesting or territorial behaviour.
